## GEOTECHNICAL PROBLEMS IN THE 2011 TOHOKU PACIFIC EARTHQUAKES

### ABSTRACT

An overview of the geotechnical aspects of the building damage in the 2011 Tohoku Pacific earthquake is presented, based on field reconnaissance made after the quake. It is shown that: (1) Extensive soil liquefaction occurred along the coast of Tokyo Bay and around the Tonegawa River floodplain. Liquefaction primarily occurred within relatively new reclaimed area, with large ground settlement up to 60 cm, accompanied by settlement/tilting of wooden and reinforced concrete buildings supported on spread foundations; (2) Numerous houses in Sendai's hilly residential areas constructed with cut-and-fill methods were badly damaged not only by simple collapse of retaining walls, but also by slope failures of fill; (3) Several pile-supported buildings tilted and settled not only in the Tohoku region but also in the Kanto plain, implying damage to pile foundations; and (4) Several steel and reinforced concrete structures in Onagawa were knocked over by tsunami surges, probably after having suffered damage to their pile foundations.

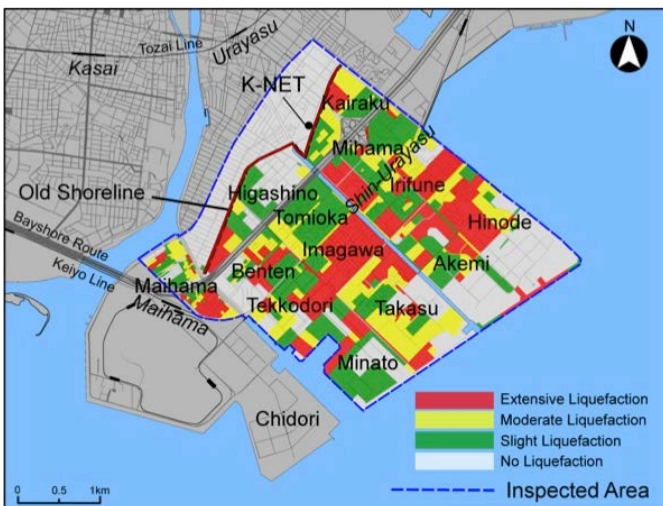
Fig. 9. Map showing extent of liquefaction damage (Tokimatsu et al, 2011)

Our geotechnical reconnaissance survey was carried out in the area circled with the dotted line in Fig. 7. Figure 9 shows a damage map in which the extent of soil liquefaction is classified into four categories (i.e., no, slight, moderate, and extensive), based on the field performance of soils and buildings including ground settlements as well as settlements and tilting of houses. It can be confirmed that, liquefaction-induced damage was not seen on the north of the old coastline as of 1964 but was widely developed in the area reclaimed after that year. The areas that had experienced liquefaction in the 1987 Chiba-ken Toho-oki Earthquake did

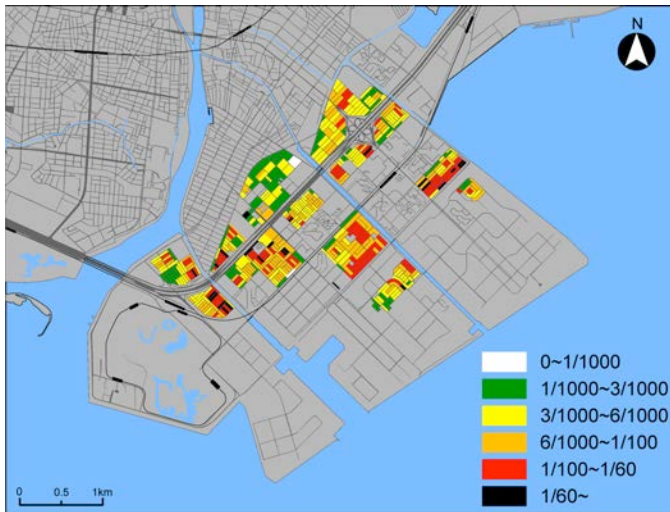
Fig. 10. Distribution of inclination angle of houses (Urayasu City, 2012)

of inclined angle, based on the survey on about 9,000 houses conducted by Urayasu city government. Figure 11 shows the distribution of average inclination angle of residential houses in each district. Figures 10 and 11 show that the houses located on the non-liquefied north side of the old coastline had no damage, while those located in the reclaimed area suffered extensive damage. In particular, about 1/3-1/2 of the houses in the residential areas of Maihama 3-chome, Benten 1-chome, Imagawa 1 to 3-chome, and Irifune 4-chome tilted more than 1/100. These areas are classified in the category of extensive damage in Fig. 9.

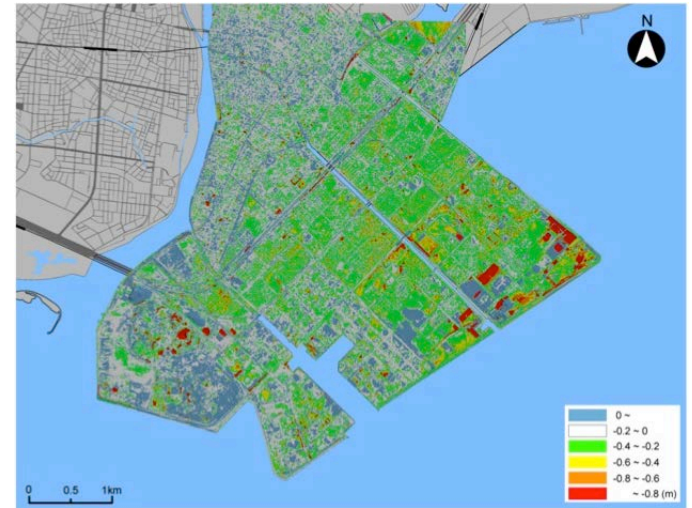
Fig. 12. Map showing vertical ground settlement between 2006 and 2011 (Tokimatsu & Katsumata, 2012)

Figure 12 shows ground settlements estimated from the difference between the altitudes obtained before and after the quake using airborne laser scanning survey. The ground in the liquefied area after the quake has settled 0.2 to 0.4 m on the average, with smaller settlements on the roads. The value of subsidence reached as much as 0.6 to 0.8 m in some areas. These ground settlements from the laser scanning survey appear to be consistent with the ground settlements observed in the field. Comparison of Fig. 12 with Figs. 9 and 10 suggests that the area with larger ground settlements experienced more severe liquefaction damage to buildings.

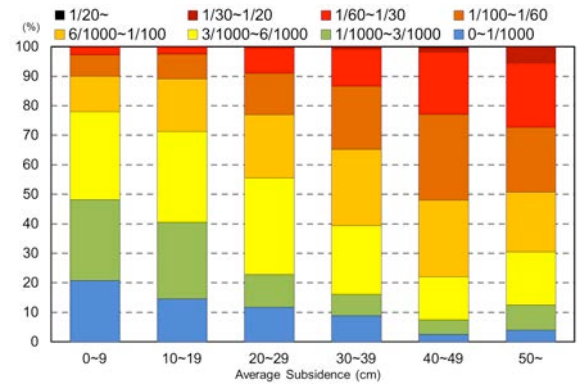
Fig. 13. Relation between ground settlement and angle of inclination (Tokimatsu & Katsumata, 2012)

residential houses with respect to ground settlement, prepared from Figs. 10 and 12. Figure 13 apparently shows that the inclination angle tends to increase with increasing liquefaction-induced ground settlement. For example, about 10% houses tilted more than 1/100 if the liquefaction-induced settlement (S) is on the order of 10-20 cm, whereas about 50% houses tilted when S becomes greater than 40 cm.

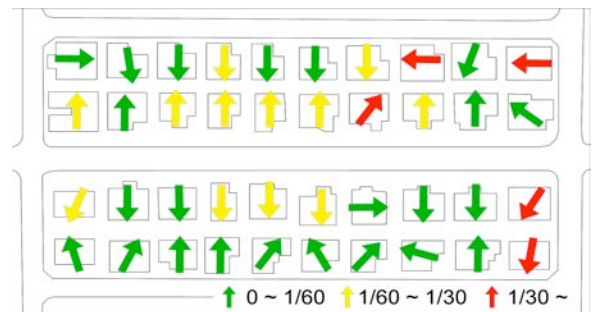
Fig. 14. Typical result of tilting angle and direction of houses in a district (Urayasu City, 2012)

A close inspection of the damage to houses suggests that, when two buildings stand closely together, they often tilt toward each other, as in Photo 4 and Fig. 14. This is supposed to occur because the ground settlement between the two structures is greater due to their combined weight loads. When buildings face a street, they tend to tilt backward as shown in Photo 5 and Fig. 14, probably because they tended to incline toward the closer buildings located behind them.

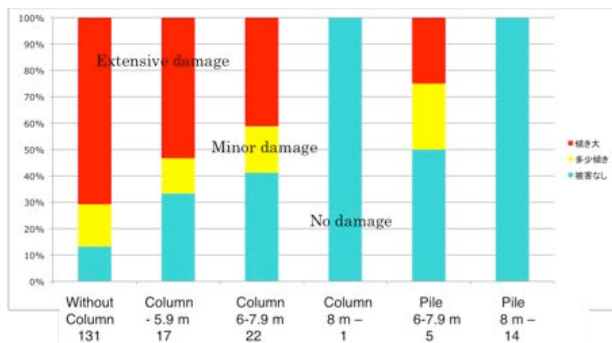
Fig. 15. Relation of depths of cement column piles or steel pipe piles with damage to houses (Urayasu City, 2012)

Many residential houses adopted cement column piles or steel pipe piles for reducing uneven settlement caused by very soft surface soils. Figure 15 summarizes the performance of such 151 houses located in the heavily damage area with thickness

of reclaimed fill greater than 8 m. The damage to houses tends to decrease with increasing length of pile, regardless of pile type.

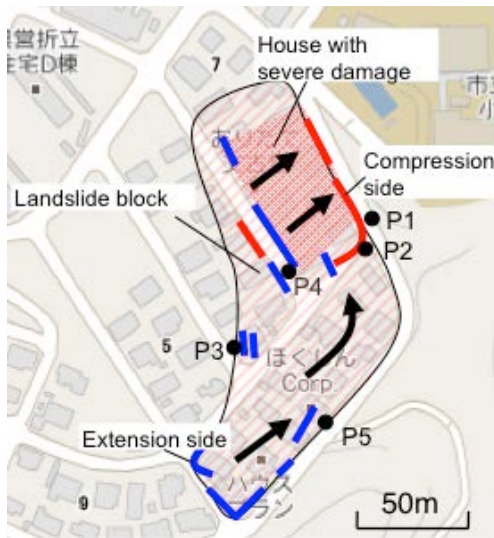
Fig. 23. Map showing landslide block in Oritate housing complex (Tokimatsu et al., 2011)

A house that straddles the landslide area and a cut slope was broken around the boundary (P5). Severe damage to houses concentrated at the foot of the landslide area, shown with a shade in Fig. 23 (Photo 18). Damage was greater at the end of the landslide block because ground deformation became greater in both horizontal and vertical directions.

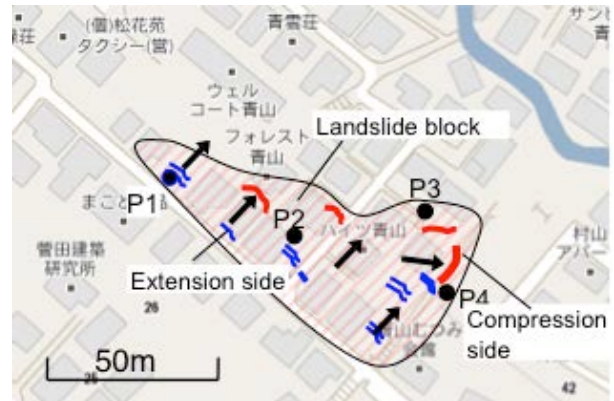
Fig. 24. Map showing landslide block in Aoyama housing complex (Tokimatsu et al., 2011)

Figure 24 shows the damaged area in Aoyama 2-chome. A major crack had formed in a housing lot in the upper part of the slope (P1 in Fig. 24). The crack was as deep as 70 cm.

Closer to a valley at P2, the retaining wall shifted about 1 meter to the valley side, causing ground to sink and leaving a void below the foundation, as in Photo 19. At the lower part of the slope, a residential land plot was destroyed as if pushed out, as in Photo 20 (At P3 in Fig. 24). Figure 24 shows the points of tension and compression found from these examples, which indicates that the landslide area was a shaded part in the figure. Comparing it with an old topographical map (around 1964) finds that the area roughly coincides with an earth cliff in the old landscape. The landslide occurred in the residential land developed by widening earthfill along the cliff. Residents

said that the groundwater level in the neighborhood is extremely shallow at about 1 meter deep, which is considered to be a factor leading to the landslide.
